ROOF INSPECTION

1234 Main St, Anywhere, CA January 29, 2020

Report No. 13375

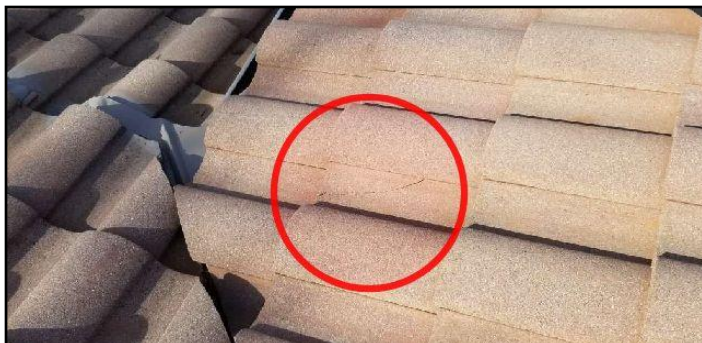
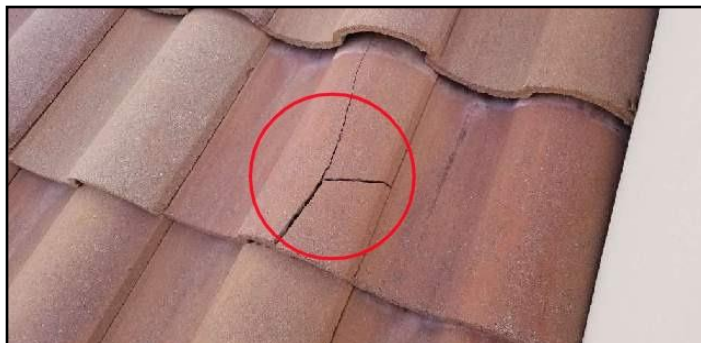
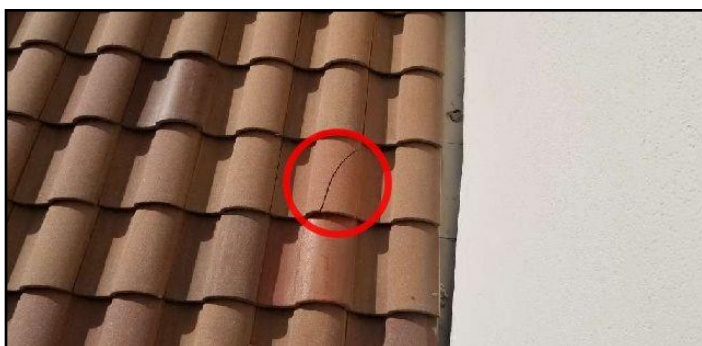
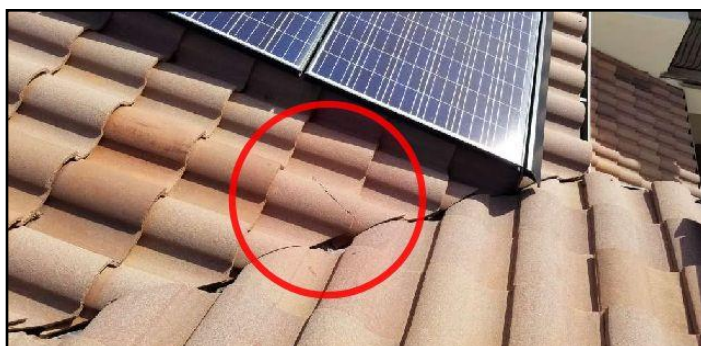
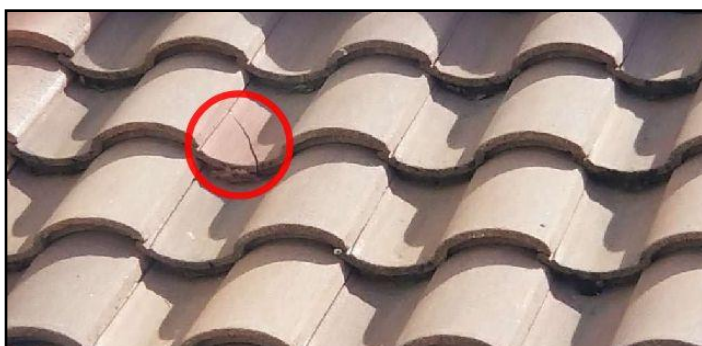
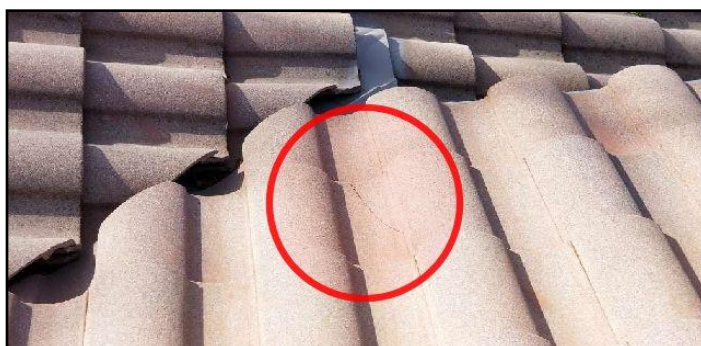
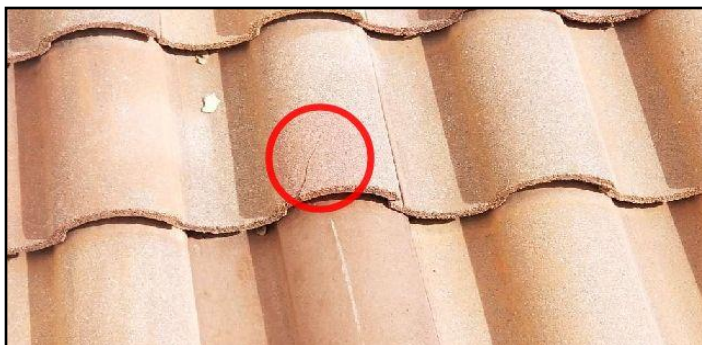
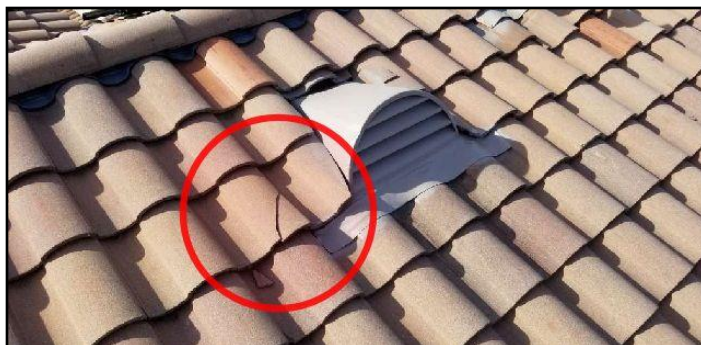
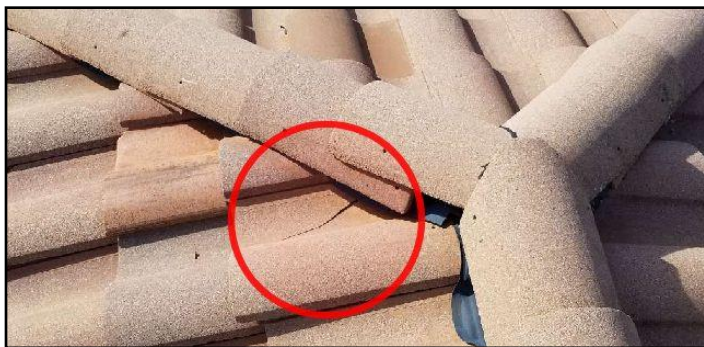
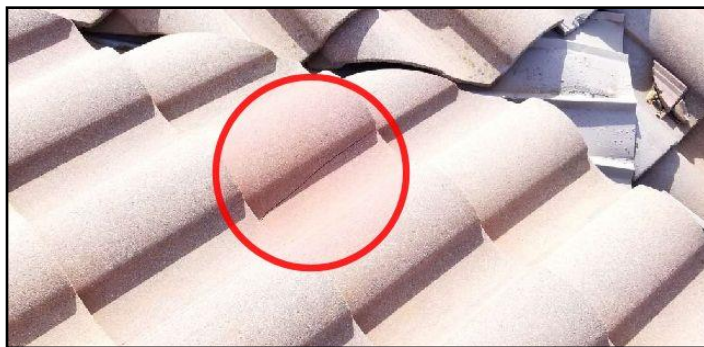
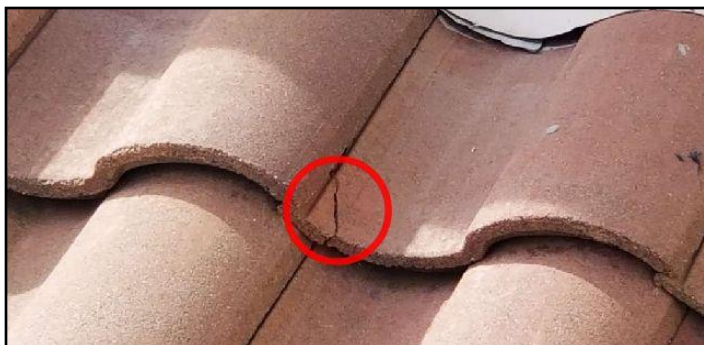
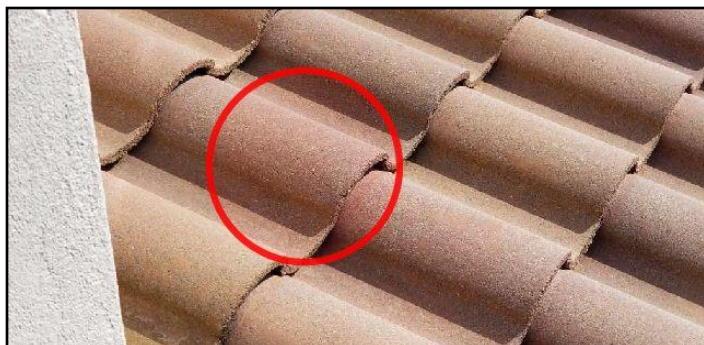
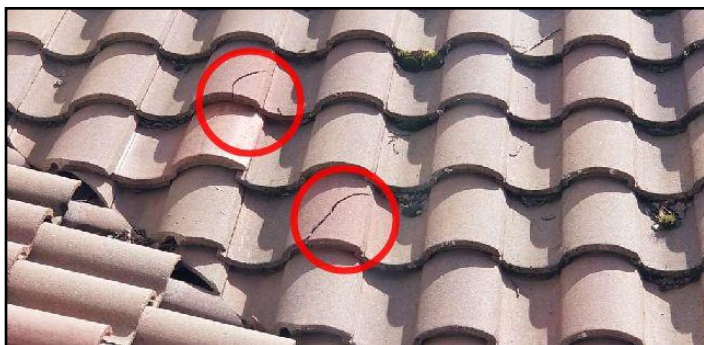
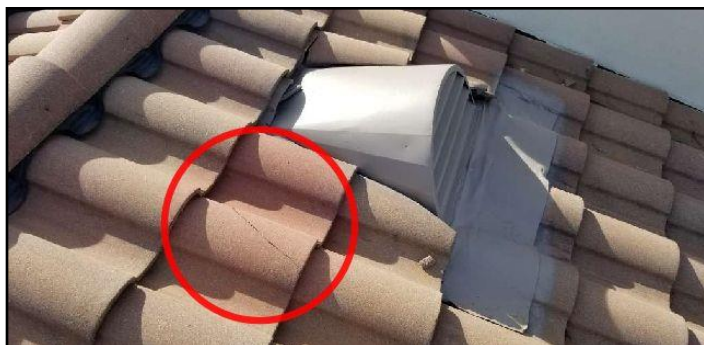
1. Condition: • Cracked and/or chipped roof tile(s) noted

Cause: Exposure / Age of materials / Third party damage

Implications: Chance of water damage to contents or finishes

See the Repair Estimate Scope of Work page for repair recommendations

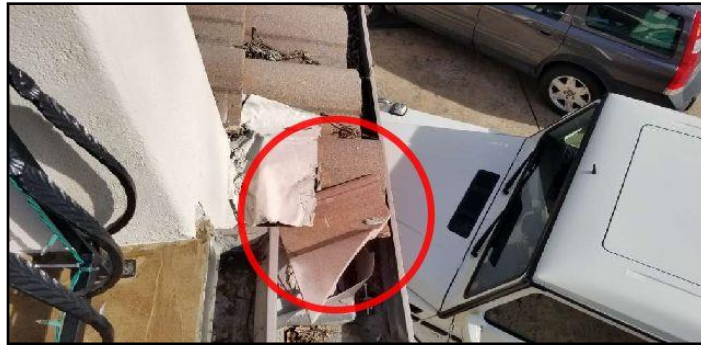
38.

2. Condition: • Slipped roof tile(s) noted

Cause: Exposure / Age of materials

Implications: Chance of water damage to contents or finishes

See the Repair Estimate Scope of Work page for repair recommendations

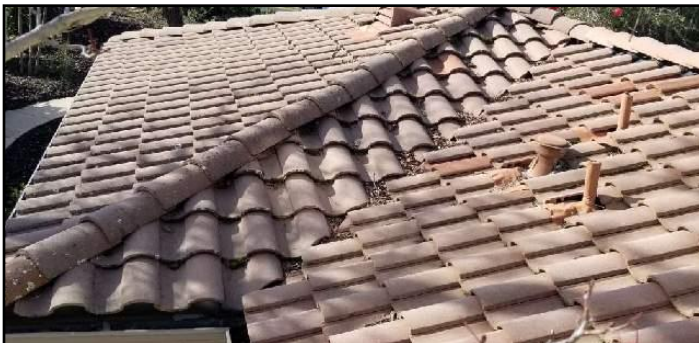
3. Condition: • Vegetation debris noted within the roof valley system. The tiles in the valley were not properly set back which is allowing a buildup of debris causing improper drainage. When water cannot flow out correctly, it will travel laterally under the tiles causing accelerated deterioration of the felt underlayment which is the waterproof membrane.

Cause: Sub-standard workmanship

Implications: Chance of water damage to contents or finishes

39. Lower Level Roof Valley

Repair Recommendation: See the Repair Estimate Scope of Work page for repair recommendations

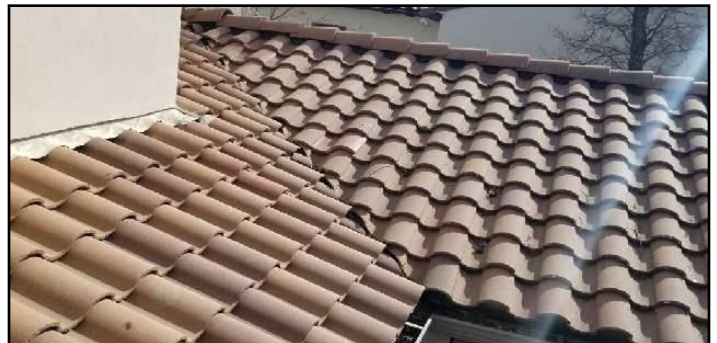
40. Lower Level Roof Valley

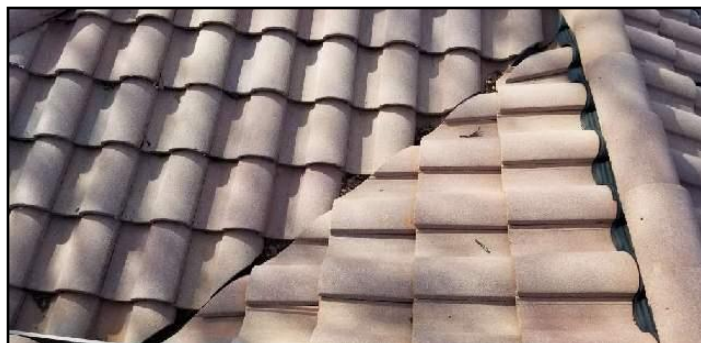
41. Front Upper Level Roof Valley
